# An Inspection Report

12/03/2021

Home Inspection Chicago

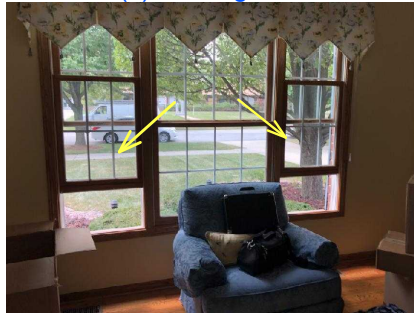
14. ☐☐☒☐☐☐☐☐ Windows: Double hung:  
[Screen\(s\) missing](#)

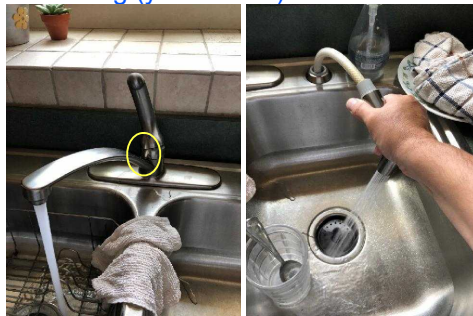
6. ☒ ☐ ☐ ☐ ☐ ☐ ☐ ☐ Lighting & Switches: Conventional lighting, ceiling fan and switches  
 7. ☐ ☒ ☐ ☐ ☐ ☐ ☐ ☐ Outlets & GFCI's: Conventional outlets, GFCI(s)  
 8. ☒ ☐ ☐ ☐ ☐ ☐ ☐ ☐ Heating/Cooling: Forced Air  
 9. ☐ ☒ ☐ ☐ ☐ ☐ ☐ ☐ Pantry: Walk in  
 10. ☒ ☐ ☐ ☐ ☐ ☐ ☐ ☐ Countertops: Laminate  
 11. ☒ ☐ ☐ ☐ ☐ ☐ ☐ ☐ Cabinets: Wood  
 12. ☒ ☐ ☐ ☐ ☐ ☐ ☐ ☐ Faucets: Manufacturer not determined  
 13. ☒ ☐ ☐ ☐ ☐ ☐ ☐ ☐ Sink: Stainless steel  
 14. ☐ ☐ ☒ ☐ ☐ ☐ ☐ ☐ Supply lines/Drain: Copper supply with PVC drainage:  
 Leaking (yellow oval)

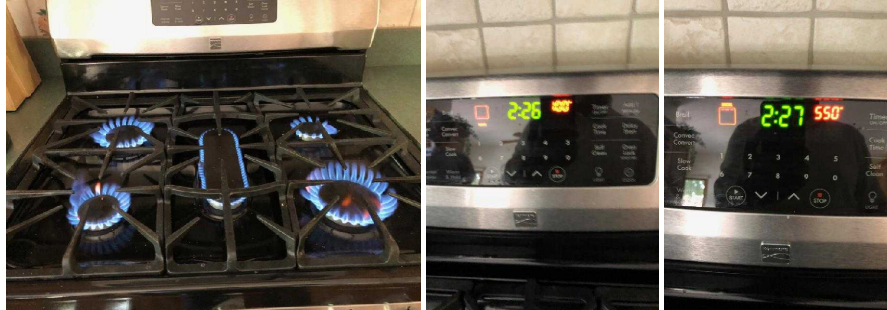
18. ☐☐☒☐☐☐☐☐ Cooking Appliances: Kenmore:  
[Verify that anti-tip bracket is present and installed properly](#)

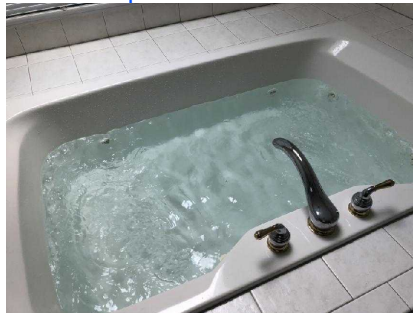
17. ☒ ☐ ☐ ☐ ☐ ☐ ☐ ☐ Toilet: Kohler
18. ☒ ☐ ☐ ☐ ☐ ☐ ☐ ☐ Shower: Plastic surround
19. ☒ ☐ ☐ ☐ ☐ ☐ ☐ ☐ Spa Tub: Plastic:  
[Access panel for mechanicals in bedroom \(yellow oval\)](#)

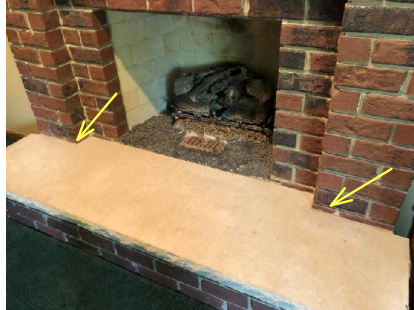
6. ☐☐☐☐☒☐☐☐☐ Hearth: Raised:  
Caulk missing

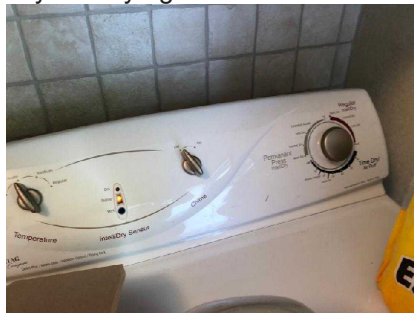
14. ☐☐☒☐☐☐☐☐ Hoses: Rubber: Rubber hoses have a tendency to leak - recommend replacing with braided supply hoses

Automatic washing machine water shut off valve recommended: if the current set-up develops a leak water will continue to flow since the valve is open. Installing an automatic shut off valve opens and closes the valve as needed

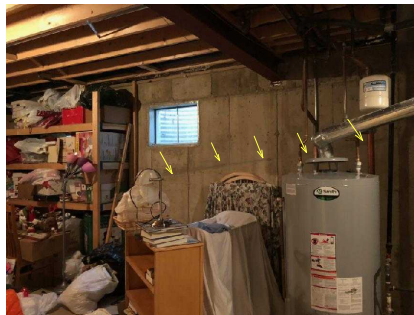
[Cold joint\(s\): the result of two or more separate pours. It is best for all the concrete to be poured at one time. Cold joints can leak and can weaken the concrete though it usually does not adversely affect the structure - recommend monitoring for any leaks, changes or movement in this area and consider obtaining an analysis by a structural engineer](#)

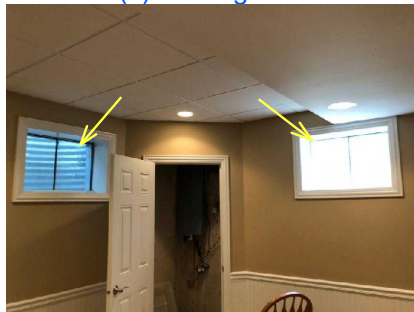
11. ☐ ☐ ☒ ☐ ☐ ☐ ☐ ☐ Windows: Hopper:  
     [Screen\(s\) missing](#)

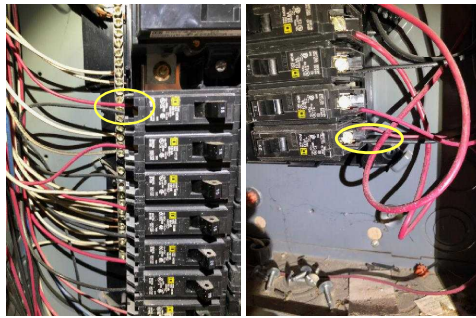
Double tap(s) WITHOUT availability of unused breaker(s): breakers are designed to have one conductor (wire) connected to it. A second wire connected to the lug (screw) is called a double tap and increases the chance of loosening the lug. Loose connections can arc (spark) and start an electrical fire - double taps are not advised and repairs are recommended

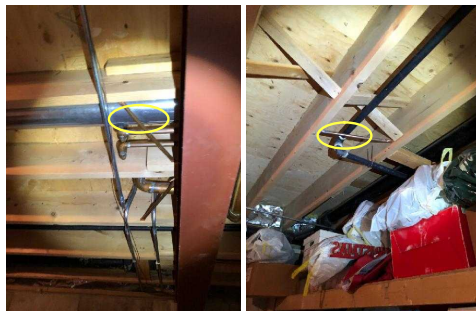
[Galvanic action: electrolytic corrosion \(electrolysis\) occurs when two dissimilar metals are in contact. The unlike metals cause a chemical reaction that results in the deterioration of one of them, Granted, the process may takes years but it will likely occur. Check for others...](#)

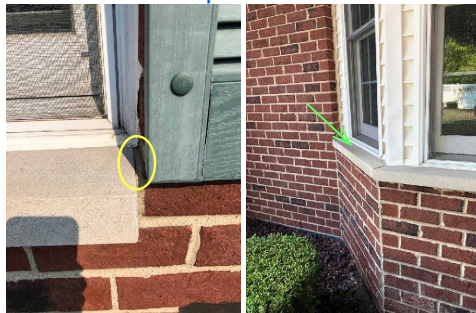
Mortar joint(s) likely to deteriorate over time (yellow oval): this is an excellent way for water and air to infiltrate the wall cavity - when needed, repair mortar to 1/4" of surface and top with high quality sealant. Do not create groove (finger swipe) with sealant as water will not drain on flat horizontal surface

Masonry is reverse pitched: water will flow towards the window instead of away - recommend repairs

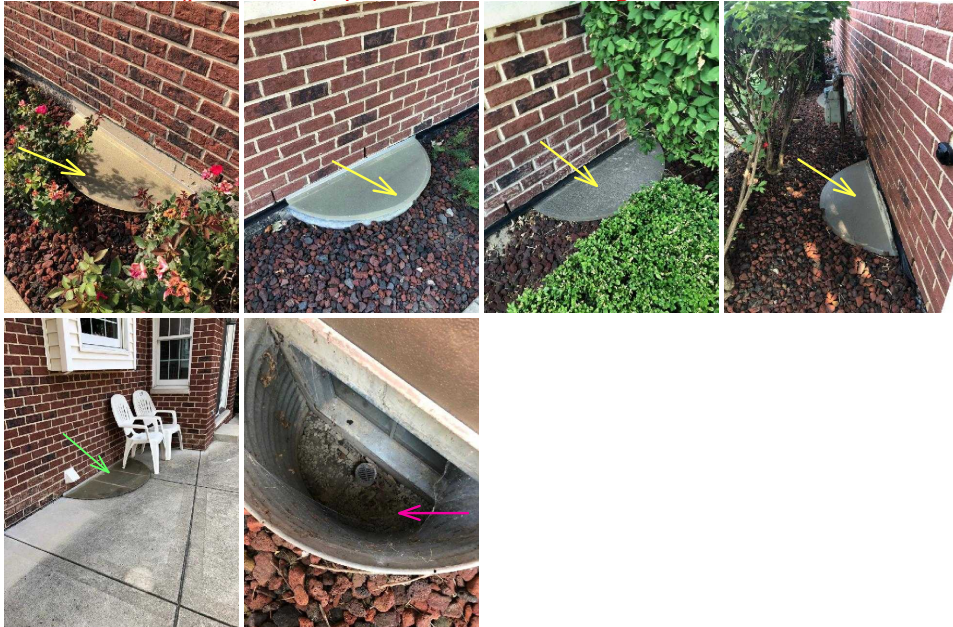
Window well cover(s) should be rigid to support someone walking in the area (lime arrow)

Add rock/fill (pink arrow) - promotes better drainage

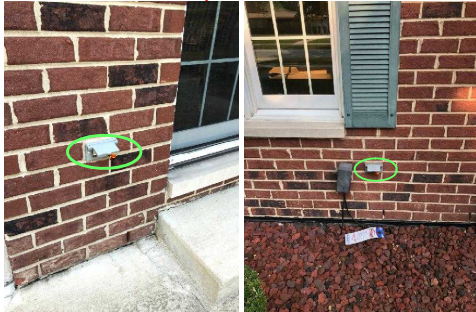
16. ☐ ☐ ☐ ☒ ☐ ☐ ☐ ☐ Outlets & GFCI's: GFCI(s):  
 GFCI(s) does not respond to mechanical tester: device may be defective or miswired - recommend repairs

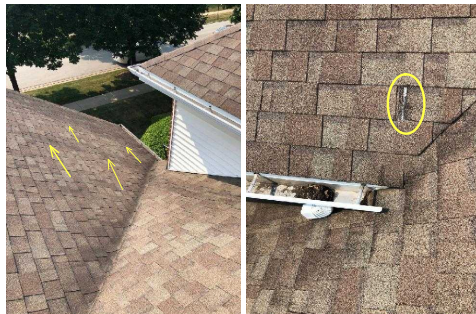
Algae/fungi/moss (darker areas/streaks) on shingles (yellow arrow): this growth limits the drying process and accelerates aging - recommend using the appropriate methods to remove and clean area. Installing zinc strips at the ridge is a popular choice to remove algae as it does not flourish when the metal is present

Fiberglass mat or core exposed (yellow oval): classic indication that shingles are falling and it implies that the shingle(s) is beyond it's useful service life - recommend replacing

Some granular loss: the small rocks or pebbles embedded in the shingle protect the shingle from the ultraviolet rays of the sun. If they are missing the aging process is accelerated and they shingle dries an is no longer effective - consideration should be given to replacing the shingles
